THE HOMER BUILDING: BUILDING ON AN HISTORIC PAST, PREPARING FOR THE FUTURE

M.T. DRISCOLL

Civil Engineer, Wiss, Janney, Elstner Assoc., Inc.

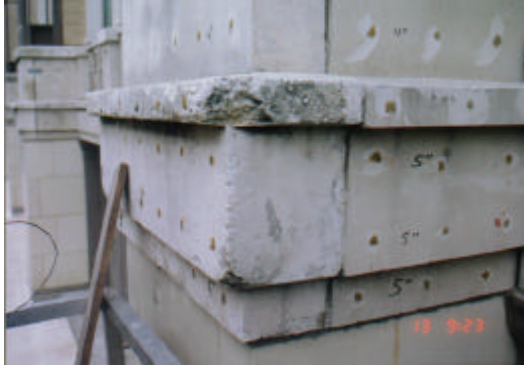
Many of the cast stone segments had surface material loss typical of cast stone several decades old. The surface of some panels was rough and granular and crumbled when rubbed by hand. Interestingly, these deteriorated panels were often adjacent to cast stone panels that remain in excellent condition, making the damage even more striking (See Figure 3). In addition, the juxtaposition of the deteriorated cast stone against pristine limestone pieces of the same period highlighted a significant variation in durability between the natural and man made materials.

Much of the surface damage to the stone can be attributed to poor production practices including insufficient compaction and improper curing.

Figure 3 : Surface damage

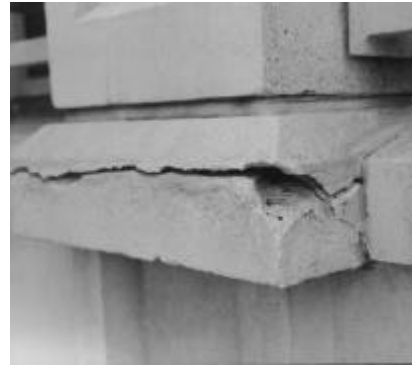
The majority of spalling occurred at corner locations and edges, at previous patch locations, and most significantly at bollard bases. Based on our observations, the previous patch failure was due to improper patch preparation (See Figure 4).

Figure 4 : Cracking at bollard base

In addition, the procedure included the epoxy injection of all cracks, removal and replacement of all cast stone bollards and pedestals, cleaning the stone of all biological staining and finally coating of the entire cast stone façade with an architectural coating (See Figure 10).

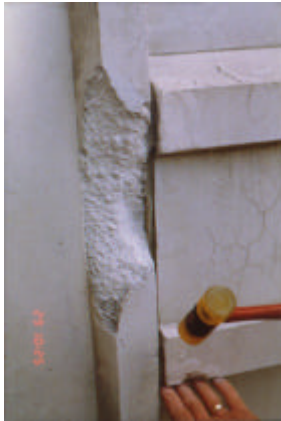
Crazeing, defined as fine and random cracking extending only through the surface of the stone, was found throughout the building. There were some locations where this crazeing was severe and had developed into cracking (See Figure 5).

Crazeing is a result of surface tensile stress caused by shrinkage of the surface relative to the mass. In addition, studies indicate that concrete having rich oversanded mixes as well as those cast against smooth, impermeable surfaces are highly susceptible to crazeing. Both conditions were present on the cast stone of the Homer building and crazeing was notable at several

Figure 5: Cracking and spalling of old patches

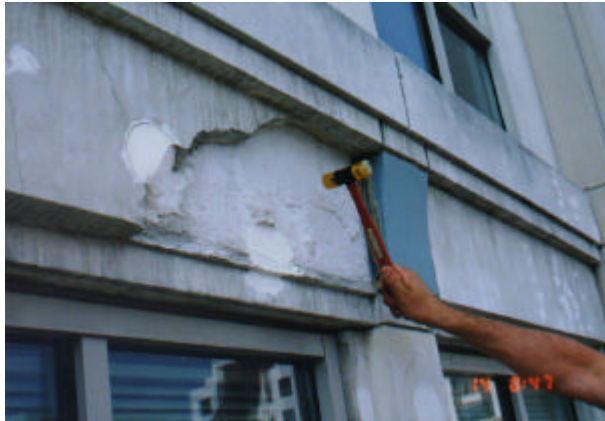
The cast stone had delaminated at the lift lines at several locations, in particular at sill and spandrel locations. (See Figure 6) These delaminations are typically due to poor production practices including movement while the concrete was plastic, insufficient compaction, and improper curing. The tests described in Section 3.1 below verified that insufficient compaction was an issue on this structure as was a high absorption rate.

Figure 6 : Delamination of the cast stone at lift line

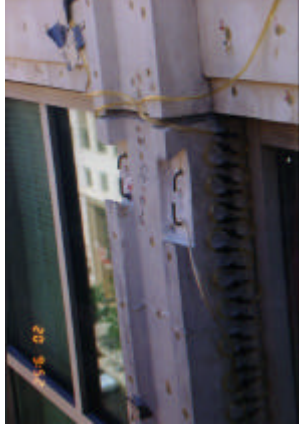
Figure 9 : Epoxy injection, pin installation, and patch preparation

The final repair included removal of all loose cast stone material, removal of all previous patches, and installation of stainless steel pins bedded in epoxy at 6" (152.4 mm) on center throughout the façade (See Figures 3 & 10). These pins and epoxy serve to stitch the various cast stone lifts together and anchor them to the stable concrete back up material where present.

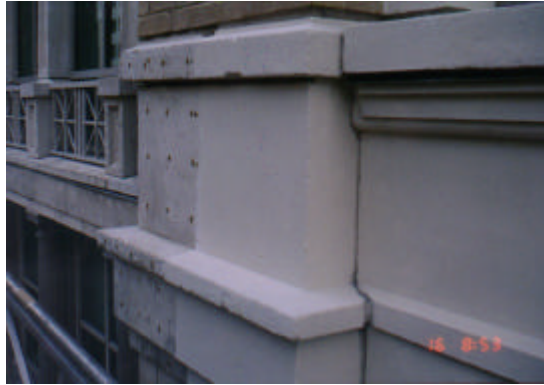
Figure 10 : Coating installation
