PRESERVATION BRIEFS

42

The Maintenance, Repair and Replacement of Historic Cast Stone

Richard Pieper

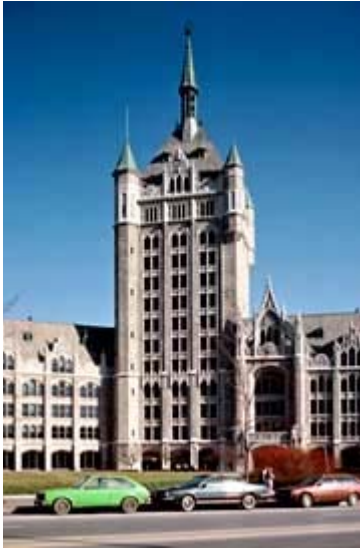
The prominent Delaware and Hudson Building, Albany, New York, (1916) made extensive use of cast stone as trim combined with a random ashlar facing of natural granite. Photo: Richard Pieper.

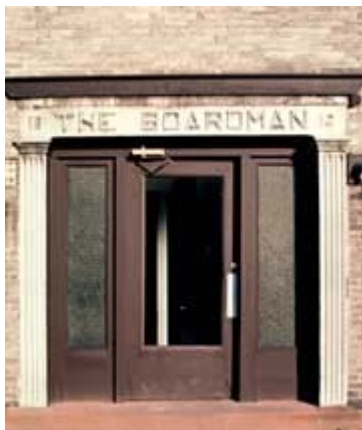
Cast stone was commonly used for molded trim in conjunction with brick or natural stone. This brick building in Rochester, New York, uses cast stone for the entry surround, and natural stone for unornamented windows sills, thresholds, and water table units. Photo: Richard Pieper.

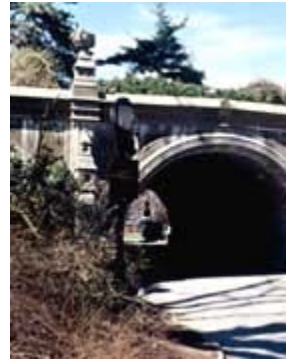
Constructed in 1868 of Belton Stone, the Cleft Ridge Span in New York City is one of the earliest extant cast stone structures in the United States. Photo: Richard Pieper.

patents in 1869 and 1870 for his system of pre-cast concrete construction, which consisted of portland cement, hydraulic lime, and sand. In the United States the formula was modified to a mix of sand with Rosendale Cement (a high quality natural cement manufactured in Rosendale, Ulster County, New York). In 1870 Coignet's U.S. patent rights were sold to an American, John C. Goodrich, Jr., who formed the New York and Long Island Coignet Stone Company. This company fabricated the cast stone for one of the earliest extant cast stone structures in the United States, the Cleft Ridge Span in Prospect Park, Brooklyn, New York.

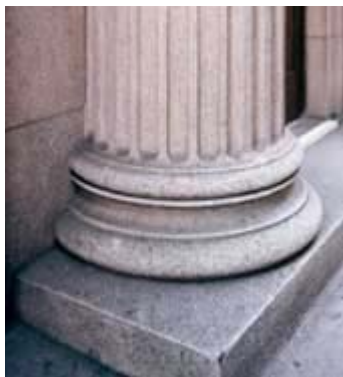
For this column, the appearance of a "pink granite" was simulated by using a pinkish matrix with white and black aggregate. Erosion of a tinted matrix results in a significant lightening of the cast stone surface. Photo: Richard Pieper.

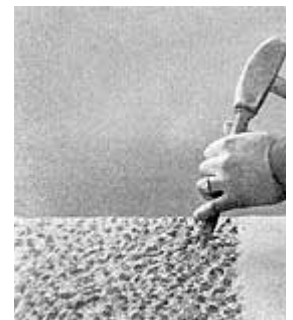
Historically, a point finish was achieved with a pointed chisel. Photo: From the Stone Company Catalog. Courtesy: F. Lynch.

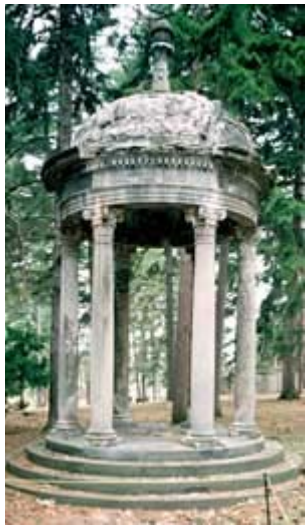
Scaling of cast stone units signals problems with the cementing mix and method of manufacture. Serious deterioration of cast stone, such as this, warrants replacement. Photos: Richard Pieper.

While it is relatively uncommon in twentieth century cast stone, serious deterioration of the cementing matrix can cause extensive damage to cast stone units. A properly prepared mix will be durable in most exterior applications, and any flaking or scaling of exterior surfaces is a sign of problems in the cementing mix and in the method of manufacture. The use of poor quality materials, such as improperly stored cement, impure water, or set accelerators can cause cement deterioration years after a structure is completed. Improper mixing and compaction can also result in concrete that is susceptible to frost damage and scaling. Severe cement matrix deterioration is impossible to repair properly and often necessitate replacement of the deteriorated units.

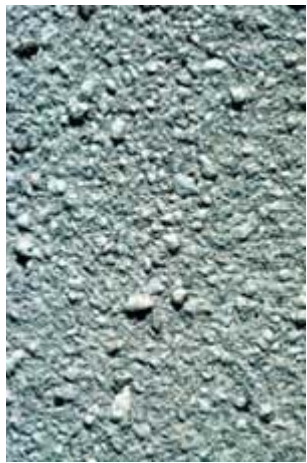
Sandblasting and wet grit blasting can seriously erode the surface and should not be used to clean cast stone surfaces. Photo: Richard Pieper.

In either case, dark particulate staining in protected areas may be persistent, however, and require experimentation with other cleaning methods. Some micro-abrasive cleaning techniques used under very controlled conditions by skilled cleaning personnel can be appropriate for removing tenacious soiling. Ordinary or wet grit blasting can seriously damage the surface of the cast stone and should

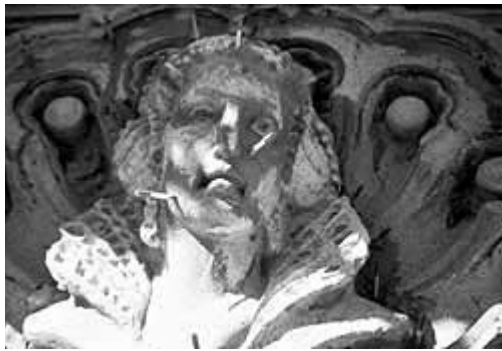
A delaminated layer of ornamental cast stone on the Orpheum Theater, San Francisco, California (1925), was successfully re-attached using epoxy. The multiple delivery ports for the epoxy are removed after treatment and the holes patched. Photo: David P. Wessell.

Where the decorative facing of dry tamped cast stone has separate layers, injected grouts may be used to re-secure the facing. Re-attaching a separated facing layer may be time consuming, and should be undertaken by a conservator, rather than a mason. This technique may be the best approach for repair of figurative sculpture or unique elements that are elsewhere on a building. Theoretically, cementitious grouts are more effective for re-attaching separated facings, but hairline fissures may require the use of adhesives. Low-viscosity epoxies have been used for this purpose, applied through small injection ports. Cracks that would allow adhesive to escape should be repaired prior to injection, of course. Holes made for adhesive injection require patching after re-attachment is complete.

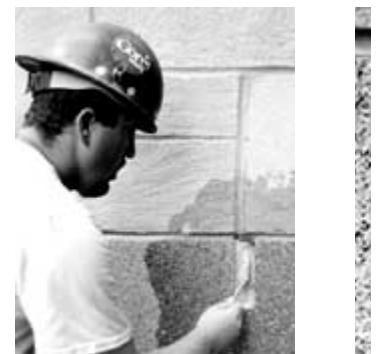
This completed composite repair could have been improved by brushing to remove the matrix residue at the edges of the repair before the surface cured. Photo: Richard Pieper.

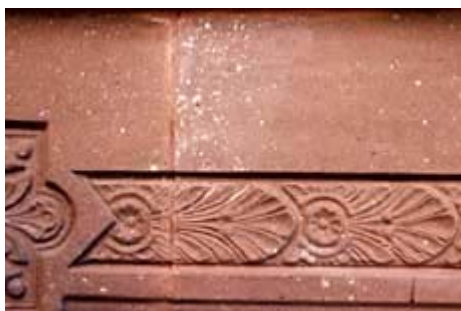
Unlike natural stone, cast stone generally may not be tooled in place to reduce lippage of uneven surfaces at joints. Tooling often exposes coarse aggregate from below the surface. Photo: Richard Pieper.

Tooling or grinding of the surface of the cast stone may expose coarse aggregate beneath the surface and will not, in any case, restore original patterns or textures that has weathered away. Silicate paints or masonry stains may be applied to replicate the original appearance, but may not be durable or completely aesthetically pleasing. Where matrix has eroded, it is advisable to accept the weathered appearance of the cast stone, unless extensive replacement is mandated by structural factors.

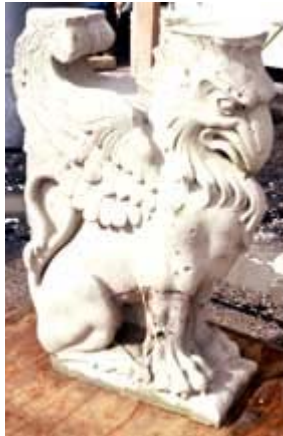
After removal from the mold, the new cast stone units are scrubbed to remove surface paste and expose underlying aggregate. End cast pieces, such as this sculpture, may have numerous air bubbles at the surface. Photo: Richard Pieper.

Air bubbles. Small pits on the surface of the stone may form if the unit is not given adequate vibration to release trapped air during pouring. Bubbles can also be a problem when end casting long items such as columns or railings, where it is difficult to vibrate bubbles away from the finish surface of the unit.

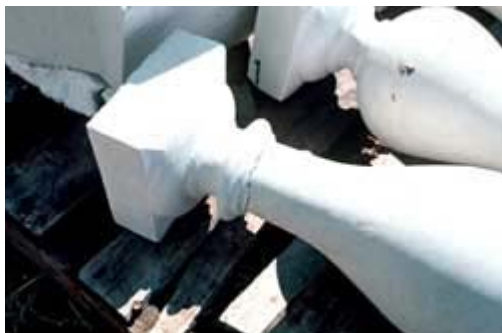
Surface cracking may reduce the durability of cast stone units. Cracking is often problematic on reinforced elements with thin "necks," such as balusters, unless curing is carefully controlled. Photo: Richard Pieper.

Surface cracking or checking. Overly wet mixes and insufficient moisture during curing can result in surface cracking of large castings, such as columns. Such cracking dramatically reduces the durability of new cast stone. Small reinforced elements, such as balusters, also form thin "necks" in the castings.

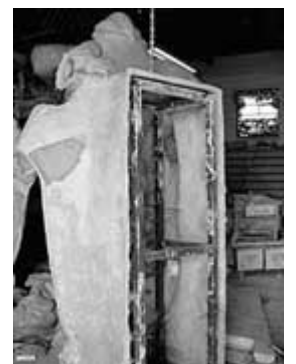
The attachment hardware inside this GFRC cartouche (left) will not be visible when the

unit is installed
(armature visible at
right). Photos: Towne
House Restorations, Inc

Glass fiber reinforced concrete (GFRC) is more and more frequently encountered in building restoration and is used to replicate deteriorated stone and cast stone, and even architectural terra cotta. This is a relatively new material that uses short chopped strands of glass fiber to reinforce a matrix of sand and cement. GFRC has become a popular low cost alternative to traditional precast concrete or stone masonry for some applications. Fabricators use a spray gun to spray the mortar-like mix into a mold of the shape desired. The resulting concrete unit, typically only æ" thick, is quite rigid, but requires a metal frame or armature to secure it to the building substrate. The metal frame is joined to the GFRC unit with small "bonding pads" of GFRC.
