PRESERVATION BRIEFS

16

The Use of Substitute Materials on Historic Building Exteriors

H. Ward Jandl

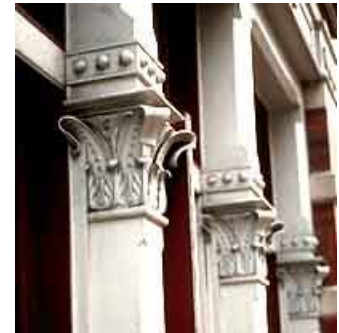
Cast aluminum used as a replacement for cast iron. Photo: NPS files.

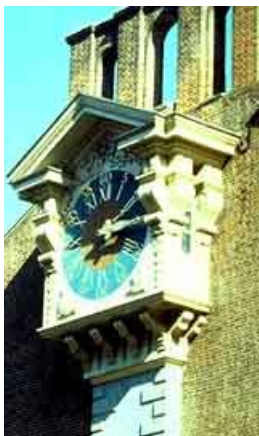
In the reconstruction of the clock tower at Independence Hall, the substitute materials used were cast stone and wood with fiberglass and polyester bronze ornamentation. Photo: NPS files.

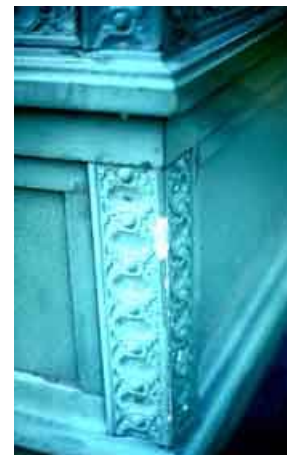
Substitute materials need to be located with care to avoid damage. The fiberglass column base has chipped, whereas the historic cast iron would have remained sound. Photo: NPS files.

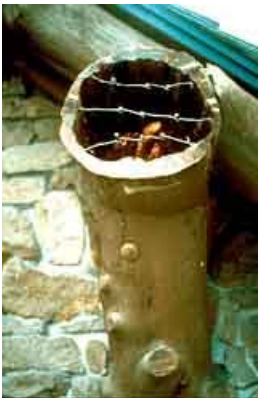
The core of a deteriorated wood outrigger was first drilled out. Photos (left and right): Courtesy, Harrison Goodall.

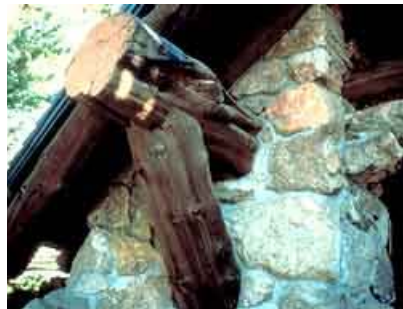
An inert material was injected into the hollow outrigger, permitting the outer wood to be retained and preserved.

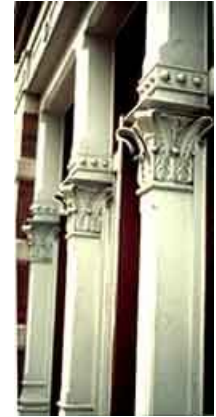
Cast aluminum has been used as a replacement material for cast iron. Photo: NPS files.

Application: Cast aluminum can be a substitute for cast iron or other decorative elements. This would include grillwork, roof crestings, cornices, ornamental spandrels, storefront elements, columns, capitals, and column bases and plinth blocks. If not self-supporting, elements are generally screwed or bolted to a structural frame. As a result of galvanic corrosion problems with dissimilar metals, joint details are very important.

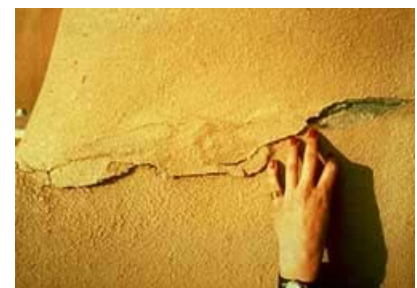
A waterproof coating is an inappropriate substitute material to apply to adobe as it seals in moisture and may result in spalling. Photo: NPS files.

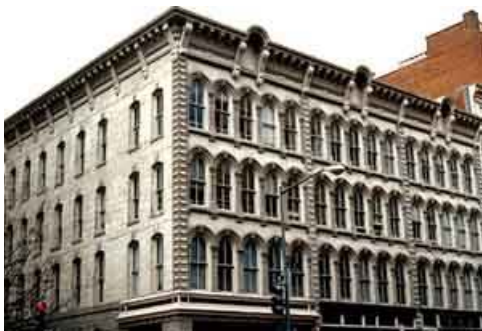
The historic cornice was successfully replaced with a fiberglass cornice. Photo: NPS files.
